Resourceful River Flooding

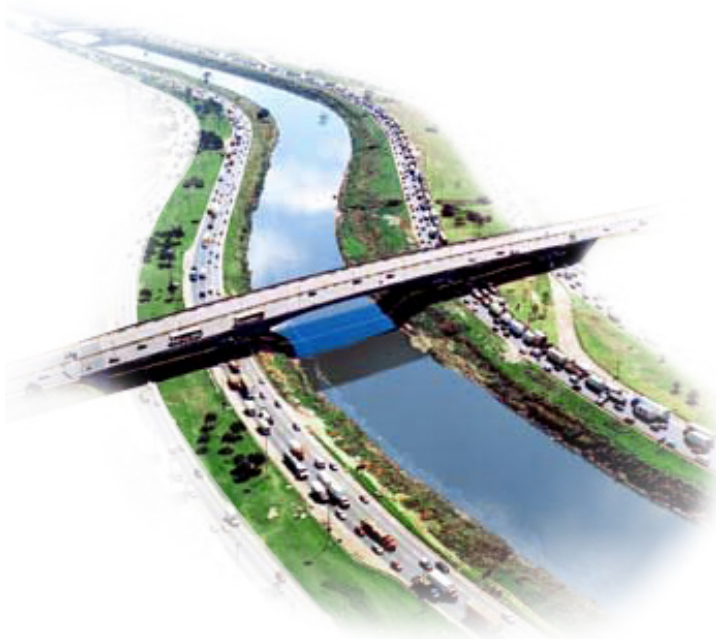
In the 1960s, developers straightened some stretches of the meandering Tietê. The marshy side areas of the river channel were incorporated into a landscape with raised levees both to contain the rising flood waters and also to provide a platform for busy arterial roads (see left).
